CASE STUDY 0008 - Tate & Lyle Refinery, London

Commercial Roof Refurbishment

TATE01/0001 - Thames Refinery, Silvertown

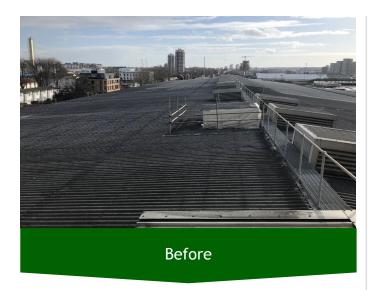
Owing to the location of the building and its proximity to the airport the roof was thick with a combination of sticky sugar residue and traffic films that made it quite literally black.

The original factory applied coatings was at the end of its life cycle and delamination of the coatings was evident throughout.

The roof had varying levels of corrosion with the majority being at the cut edges of the sheets.

The roof surfaces had to be thoroughly cleaned at high pressure to remove the build up of the thick dirt and grime that had accumulated on the roof over many years.

We then had to further remove any loose coatings with the jet wash and get all the areas back to a firm edge ready for the coating works.

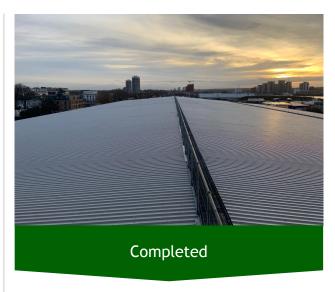
Once all cleaning works had been completed, all lap joints were sealed using Giromax Girosil® SE and then then all areas that had cut edge corrosion treatments where primed including encapsulating all fixings.

The Giromax Girosil® RC coating system was then applied via airless spray system to the complete roof area.

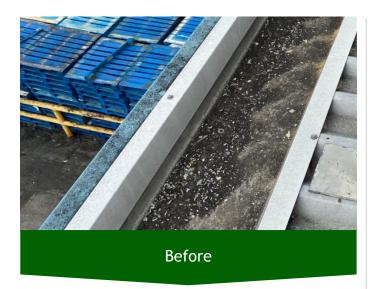
The existing gutter liners were heavily soiled and varied in level of corrosion, it was evident that the gutter joints had leak throughout causing water staining on the cladding below.

Around 52Lm of the trim line gutters had completely failed owing to corrosion and had to be replaced prior to the application of the coating system.

The metal box gutters were cleared of all debris and silt, thoroughly washed and swept through.

All loose surface corrosion was removed and then all substrates primed.

The gutter joints were then sealed using Giromax Girosil® SE to leave watertight.

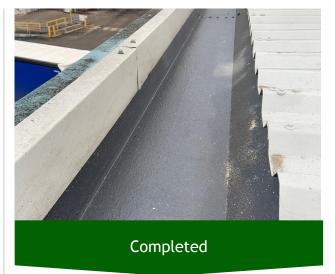
Once all cleaning and preparations has been completed as per the manufacture's guidelines, operative fully encapsulated the full length of gutters with the Giromax Girolsil® RC-G coating to complete the treatment,

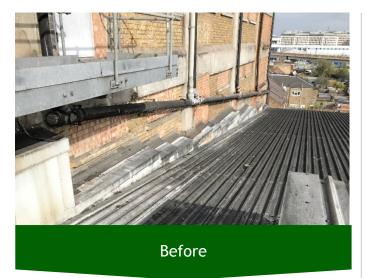
The existing up stand was covered with mineral felt, the felt was failing throughout and coming away from the curb, it was extremely dirty and covered with traffic film and sticky residue fall out from the refinery.

The area was jet washed at high pressure to remove all dirt films and residues.

All loose sections of felt was either cut away or torched back for adherence.

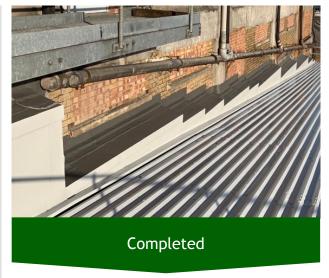
Once all cleaning and preparation works had be completed, the entire area was primed and then sealed using a liquid Protec resin.

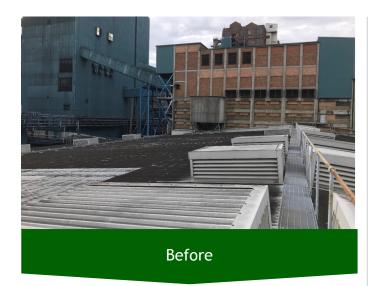
The smoke units had been causing water ingress issues throughout the warehouse and packing hall directly below.

All the hosing unit were stripped back and then smoke vents removed from the roof area.

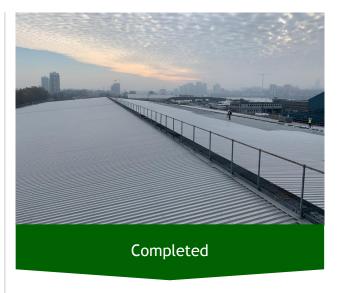
All roof voids left from their removal where over sheeted with matching steel roof sheets both externally and internally prior to the roof coating system being applied to leave a seamless consistent finish.
