CASE STUDY 00022 - Unit 11 Perrywood Business Park, Redhill
Industrial Roofcoating Refurbishment

Commercial Roof Refurbishment

Roof Coat Refurbishment - DriSilane ReCote

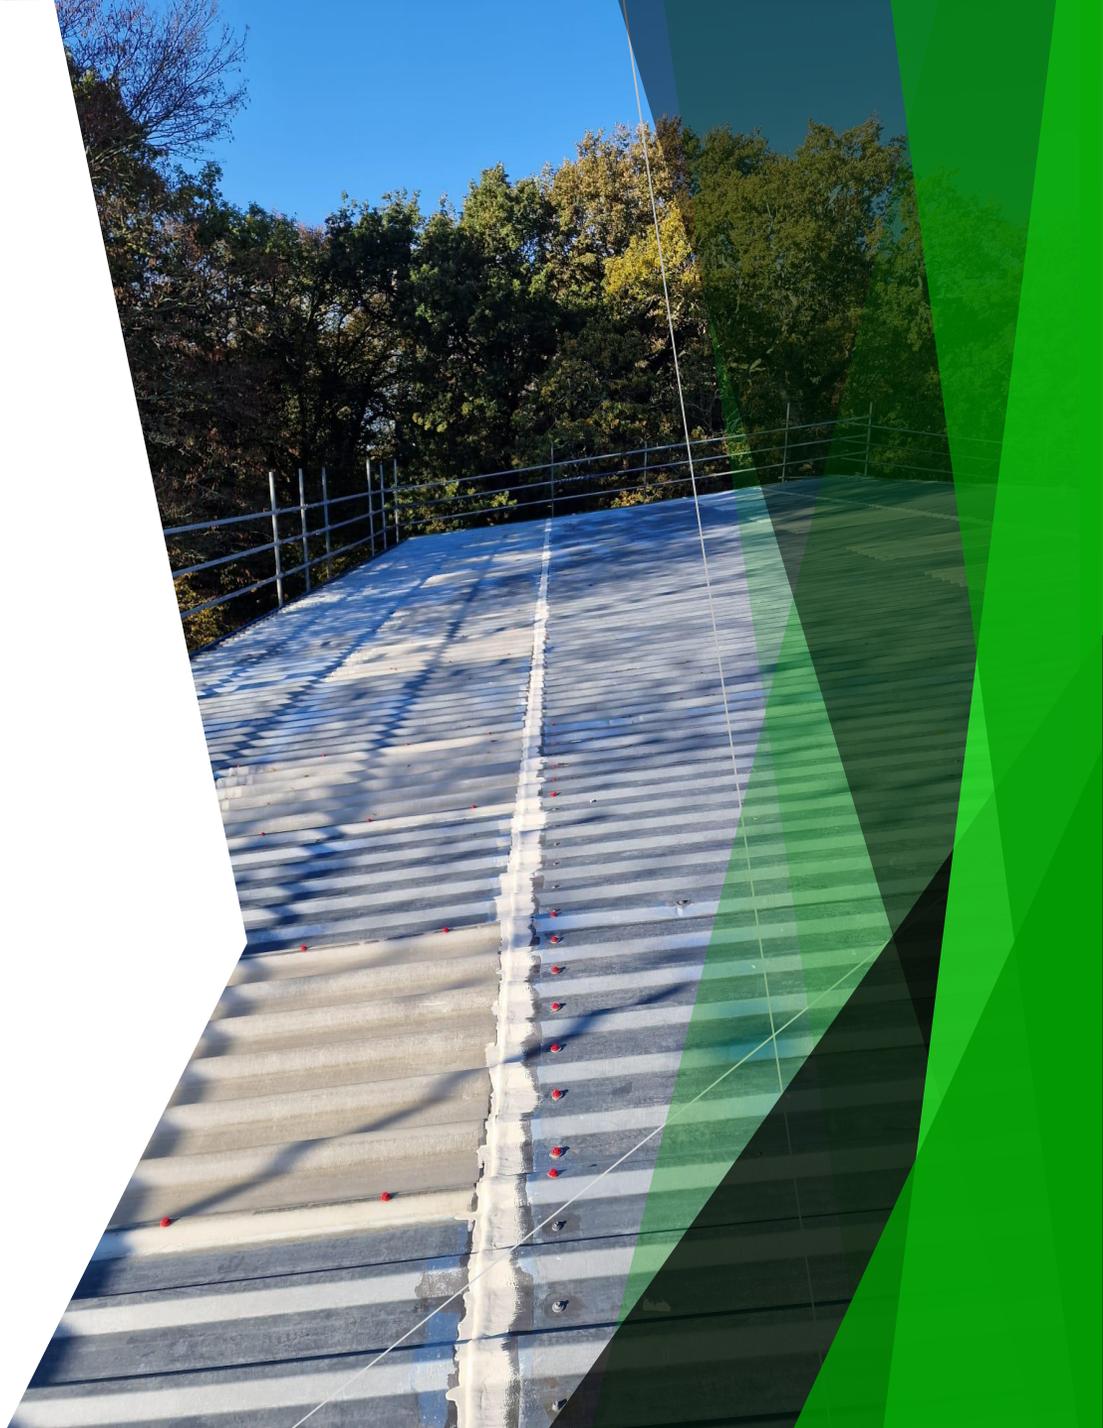
Unit 11 Perrywood Business Park, Redhill

Tritec Building contractors were awarded with the following works:

- **Roof Coating Treatment** - Pressure washed all roof surfaces to remove dirt and grease. Treated all cut edge corrosion to edges and lap joints with DriSilane Prime. Prepared and primed all fixings with DriSilane RS. Once all preparation works were complete, Our Operatives then applied DriSilane Elite Roof coating system, extending the service life of the roof for a further 25 years, complete with a comprehensive manufacturers guarantee.

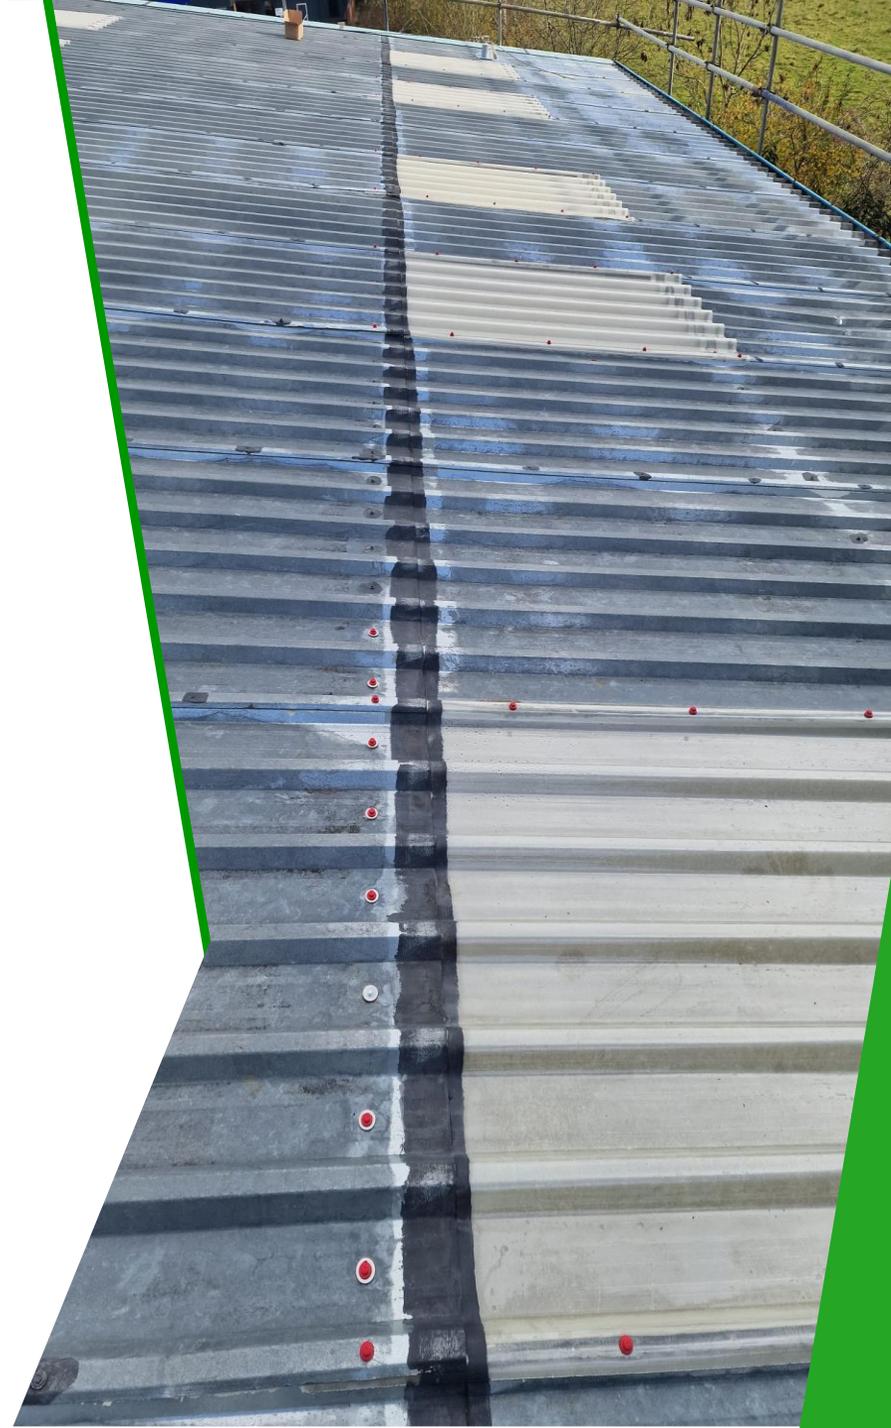
On this building the original plastisol coated sheets to the roof had been affected by many years of weathering and UV degradation, as a result the protective films had completely perished to the majority of the roof leaving the steel sheets exposed to further corrosion. By applying a propriety roof coating system we was able to reinstate a protective layer to prevent against any further erosion and the need for any costly repairs or replacements.

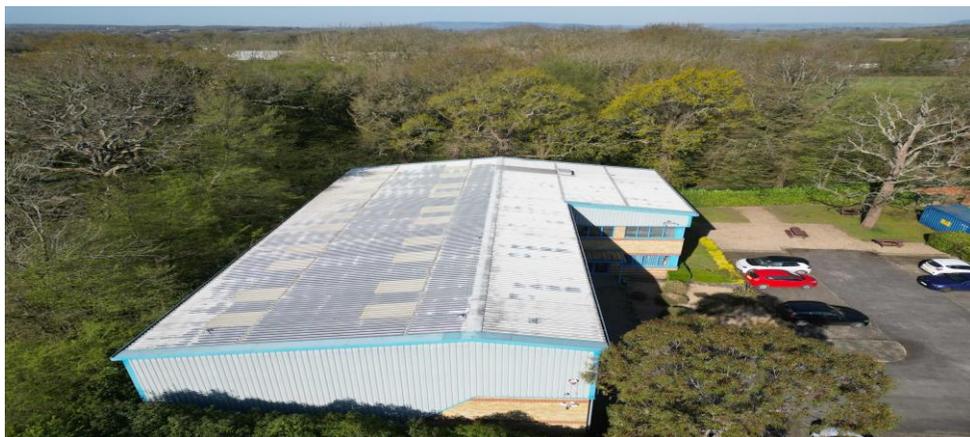
Before

The original factory applied coatings to the metal sheets has had completely perished due years of degradation owing to UV exposure and general weathering.

There was various surface corrosion and ginging through out the roof.

The roof sheets and flashing all suffered from cut edge corrosion that would need to be addressed prior to coating the roof area.

There was also a need to remove existing fixings and caps that penetrated the roof and make good the roof sheets.

In preparation for the coatings works, the roof was jet washed at high pressure to ensure that all loose coatings, dirt films and general contaminates were removed.
